Washougal River Watershed

Washougal River Watershed
Stream Health 2003

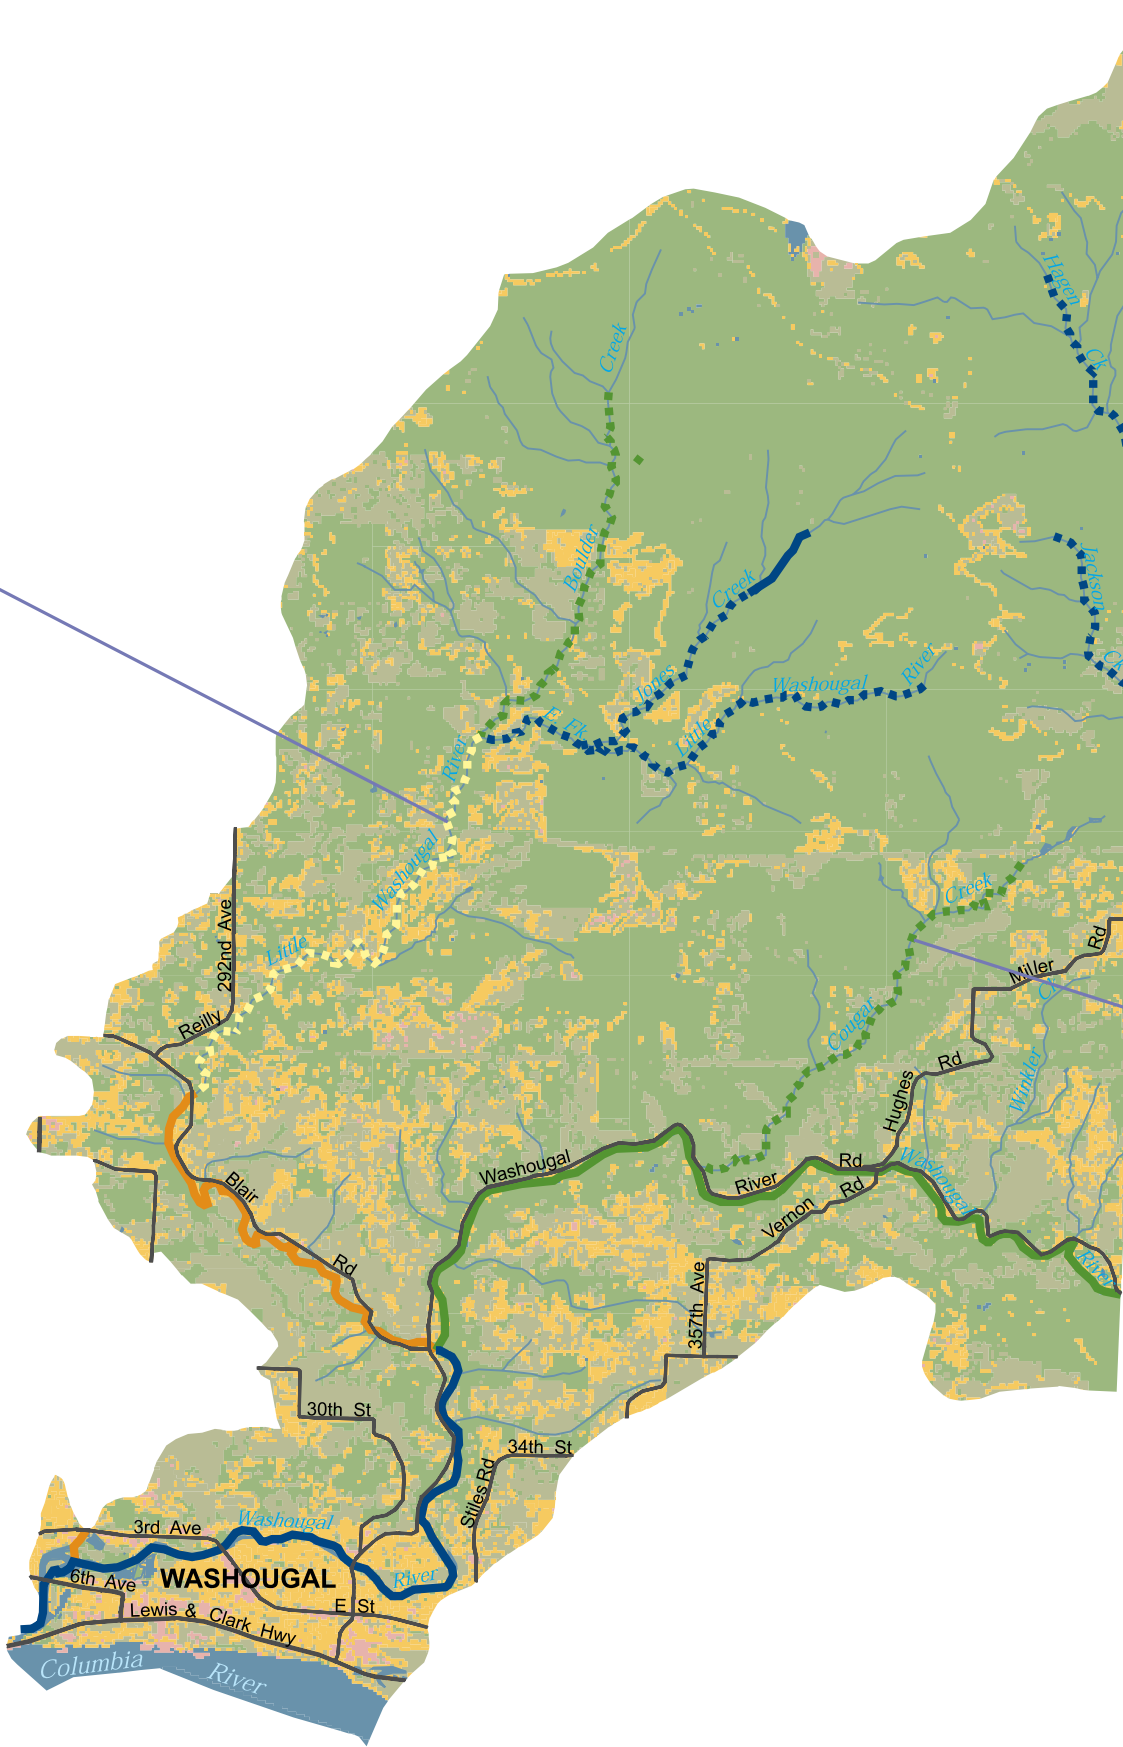
Stream Health Ratings	Description	Land Cover Key
Excellent	Pristine, superior, or unsurpassed condition; minimal human disturbance	Forest
Good	Healthy enough to support aquatic life and recreation	Grass/Shrubs
Fair	Degraded but may support aquatic life and recreation	Residential/Recently cleared land
Poor	Inferior health, poorly suited for aquatic life and recreation	Commercial/Industrial
Very Poor	Severely degraded health; unsuitable for aquatic life or recreation	
Unassessed	No data collected	
Probable	Predicted stream health

Little Washougal River stream health is excellent in its forested headwaters. In fact, it is so good that the city of Camas uses its tributaries — Jones and Boulder creeks — for drinking water. Stream health appears to decline considerably near where the Little Washougal River joins the Washougal River. Streamside trees provide cooling shade for most of the stream, but there are lower sections that lack good shade.

While there is no stream health data available for Cougar Creek, the large amount of forest and lack of significant development suggest its health is good, possibly excellent. Any potential stream health problems are probably associated with forest clearing, erosion from gravel roads, or runoff from rural residential areas.
